Manhole Inspection Summary

Manhole # S63G__022MH

Insp Date: **5/14/08 11:01 AM**

Location Address: **alley behind 401 Anglesea St.**

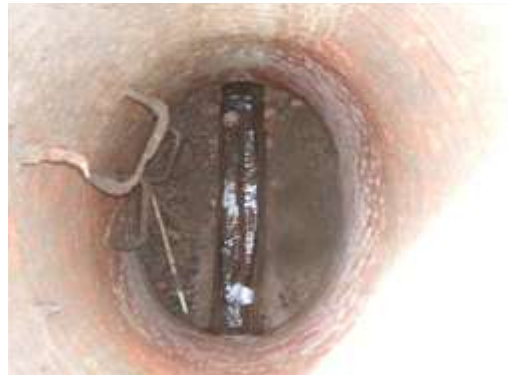
Top View

Comments **MANHOLE COULD USE CLEANING. THERE IS SOME HEAVY DEBRIS THAT COULD CATCH LIGHTER DEBRIS CAUSING A SURCHARGE CONDITION.**
